A stitch in time...

...saves nine, as the old proverb tells us. **JOHN WICKERSHAM** stems a small leak on his caravan by re-bedding some trim strips

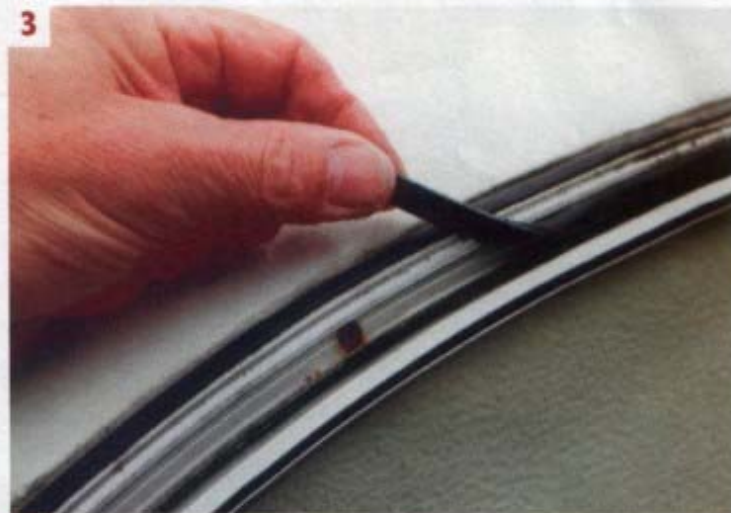
3 ■ Stage one was to peel away its plastic insert which is a cosmetic way to hide the screws

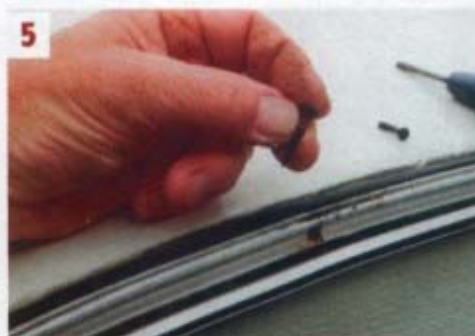
5 ■ A few rusting screws had lost their threads as well – a sure sign that water is starting to creep in where it's not wanted

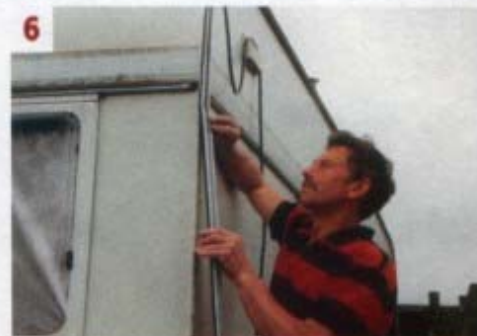
6 ■ A lower section was removed first and it was noted that some remnants were still in fairly good condition

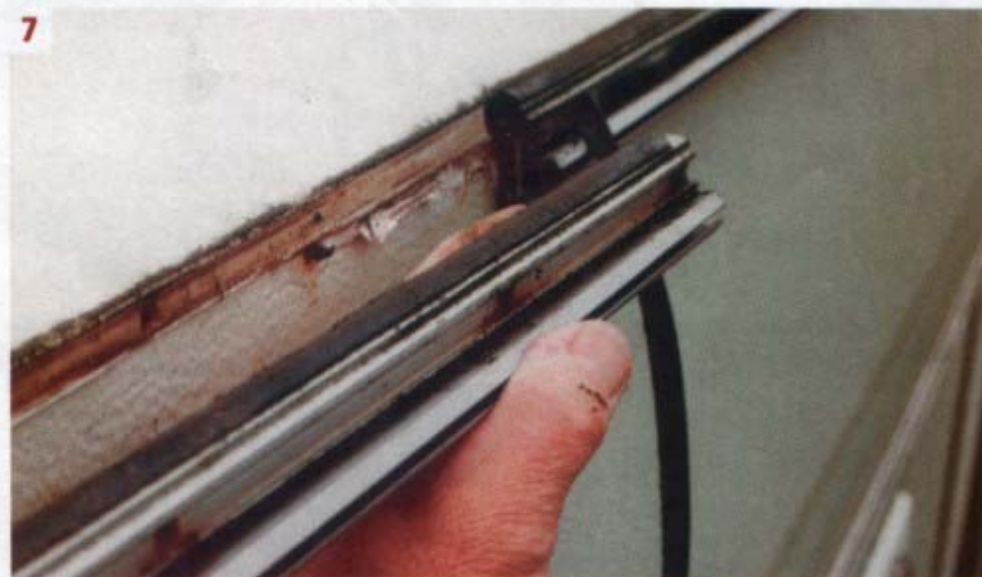
7 ■ This is a long caravan so the main section of the awning rail is joined midway along the roof

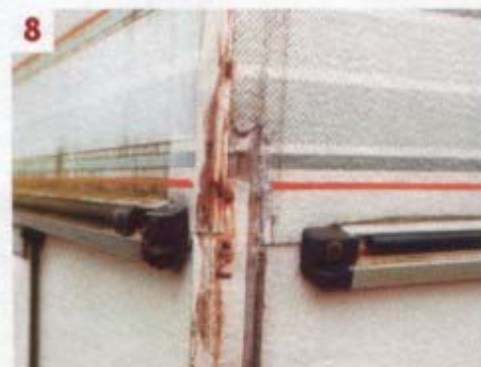
8 ■ Several sections underneath the rail looked pretty susceptible to weather penetration
