1990 SERVICE MANUAL PM13/1

REVERSING BRAKE

for

Caravans and Trailers

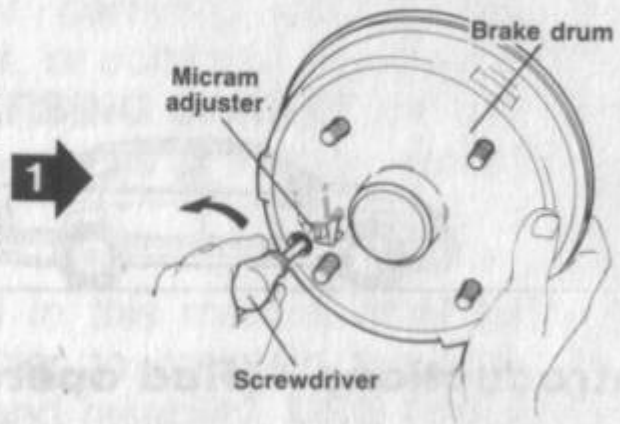
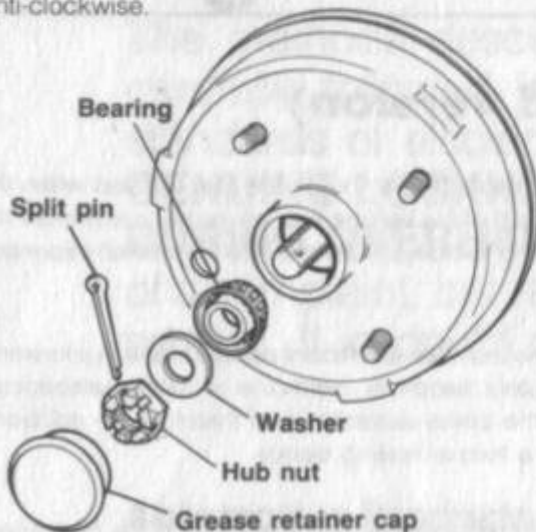
1
Prise off the hub grease retainer cap and remove split pin, hub nut, washer and bearing. Withdraw the brake drum from the stub axle. **Take careful note of the spring and shoe positions.**

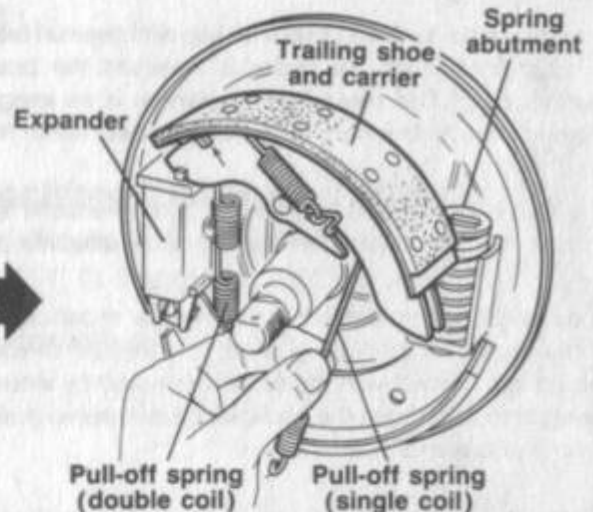
2
Release the pull-off spring (**double coil**) from behind the hook on the backplate, adjacent to the expander. At the opposite end lift the carrier and shoe away from the spring abutment and disconnect the pull-off spring (**single coil**) from the leading shoe web. This spring is identified, **red** for L.H. brake assembly, **black** for R.H. brake assembly.

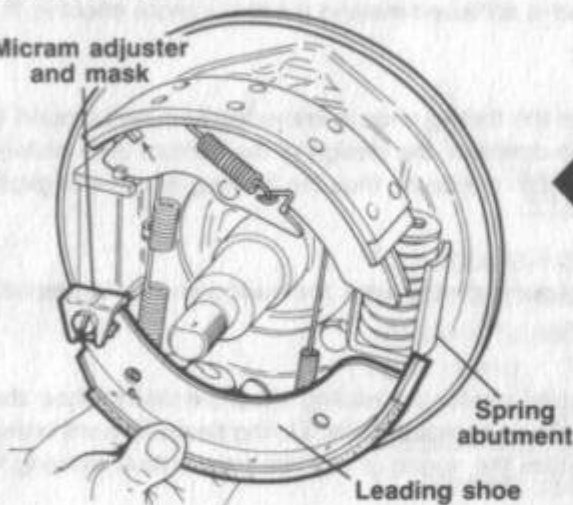
3
4
Lift the leading shoe from the spring abutment and slide the adjuster and mask off the expander body. Remove both shoes from the backplate.

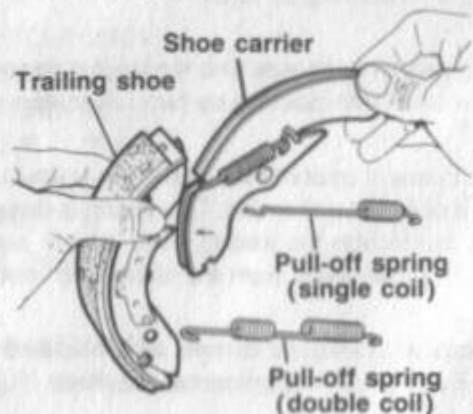
5
Slide the carrier assembly from the trailing shoe to expose both pull-off springs. **Note their positions and remove them.** The double coil spring is not interchangeable with the one on the opposite brake.

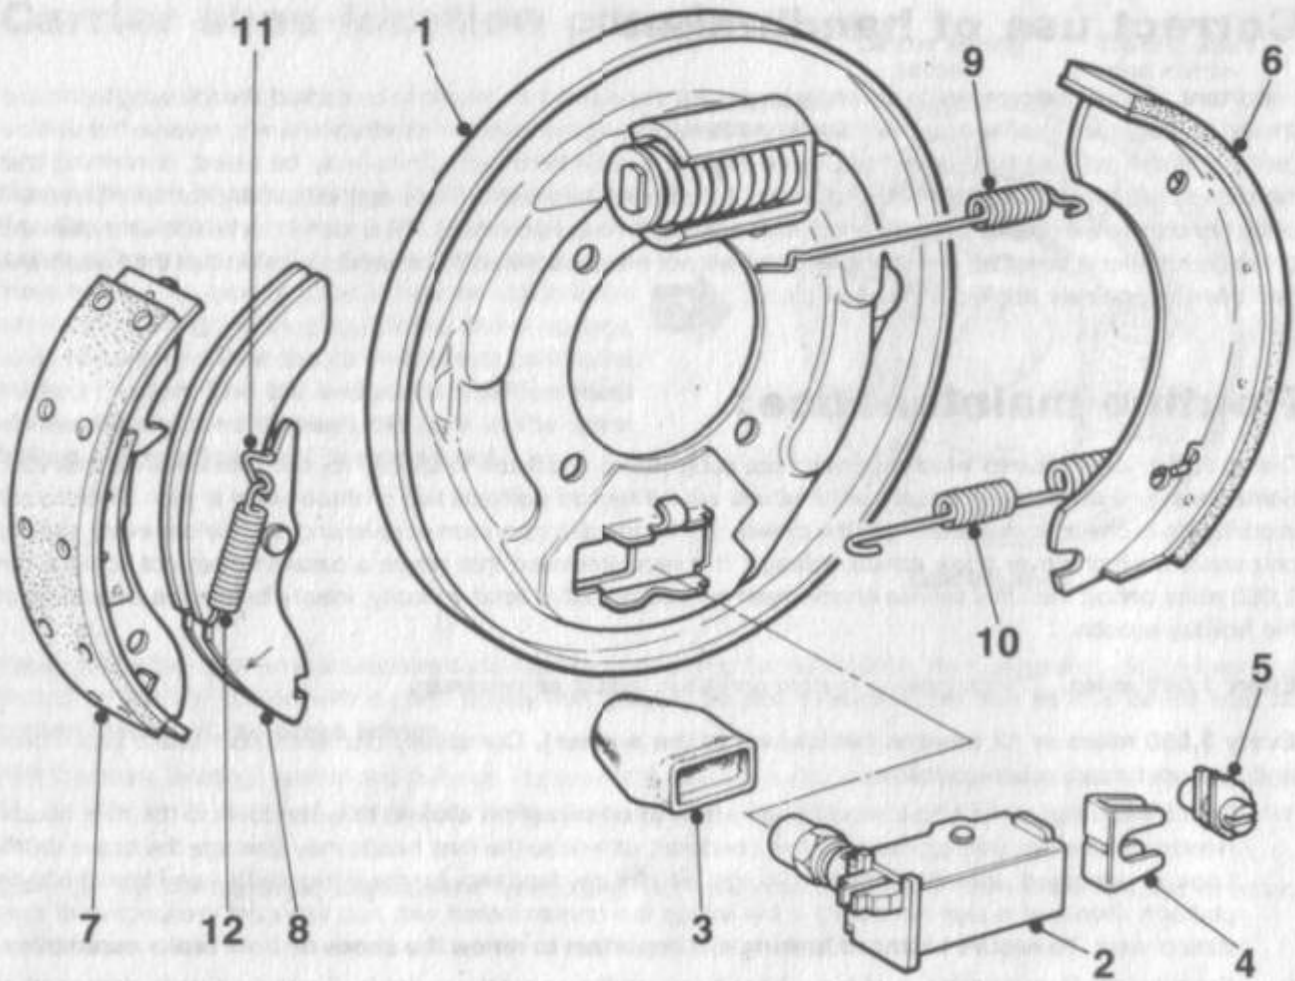
BRAKE ASSEMBLY COMPLETE

R.H. = LG 15050 L.H. = LG 15051

Description	Kit Part No.	Kit Contents	Description	Kit Part No.	Kit Contents
Backplate R.H.	LPP 113	1 Backplate R.H.	Trailing shoe carrier	LPP 115	8 Trailing shoe carrier
Backplate L.H.	LPP 112	1 Backplate L.H.	Spring kit (Axle set)	LK 17054	9 Pull-off spring (Black)
Expander assy. R.H.	LQ 15649	2 Expander R.H.			9 Single coil R.H. Pull-off spring (Red)
Expander assy. L.H.	LQ 15650	2 Expander L.H.			10 Single coil L.H. Pull-off spring double coil R.H.
Rubber boot	LPP 114	3 Rubber boot (2 off)			10 Pull-off spring double coil L.H.
Micram adjuster	LK 17053	4 Mask			11 Carrier link (2)
Brake shoes (Axle set)	LS 1263	5 Micram			12 Carrier spring (4)
		6 Leading shoe (2)			
		7 Trailing shoe (2)

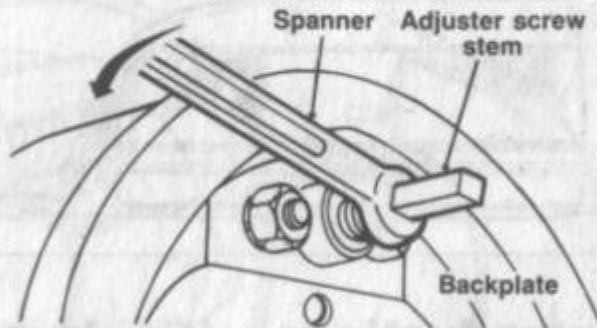
Fig. 1

With a suitable spanner back off all brake adjustment by turning the square adjuster screw stem behind the backplate fully anti-clockwise. **Fig. 1.**

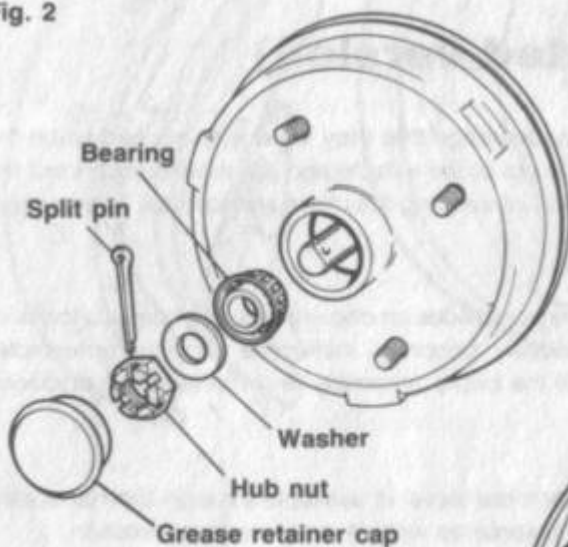
Fig. 2

Prise off the hub grease retainer cap and remove split pin, hub nut, washer and bearing. Withdraw the brake drum from the stub axle. **Fig. 2.**

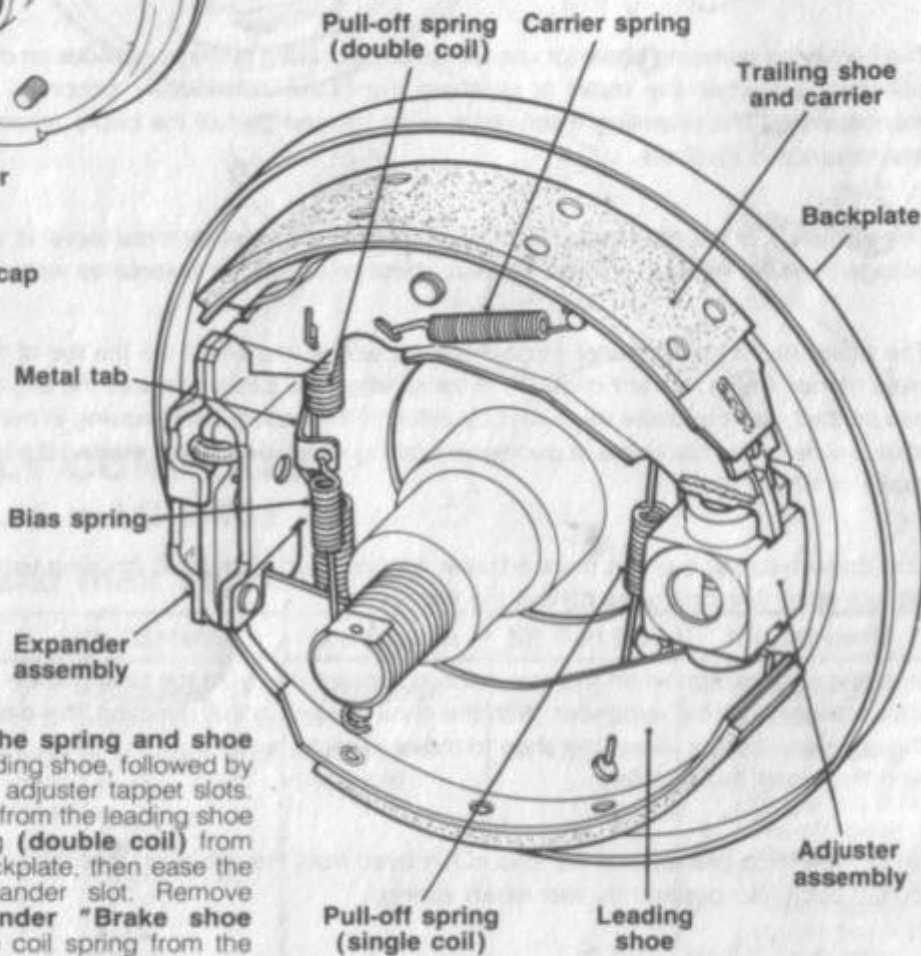
Fig. 3 L.H. brake assembly

After taking careful note of the spring and shoe positions pull the heel of the leading shoe, followed by the toe of the carrier, out of the adjuster tappet slots. Disconnect the single coil spring from the leading shoe web. Release the pull-off spring (double coil) from behind the metal tab on the backplate, then ease the leading shoe out of the expander slot. Remove bias spring, (see note 5 under "Brake shoe replacement") and the double coil spring from the leading shoe web. Note the spring hook positions then remove from carrier. Disconnect both carrier springs and remove trailing shoe from the carrier.

1. It is important that the brake shoes are fitted the correct way round with the L.H. brake assembly (**as illustrated**) the operating lever stop faces towards the adjuster. On the R.H. brake assembly it faces away from the adjuster, then the shoes are fitted accordingly.

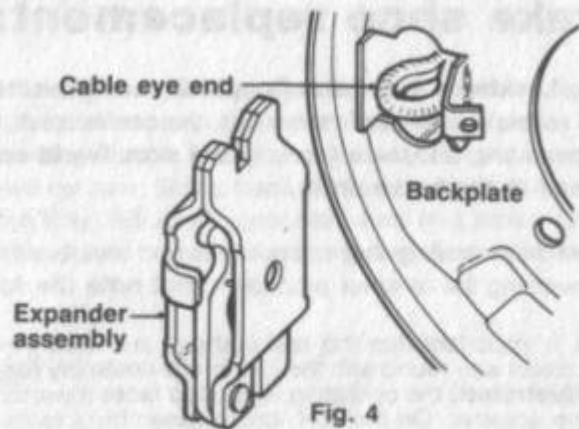
Fig. 4

Disconnect eye end of operating cable and remove expander from backplate. Remove all dust and deposits from the backplate (Fig. 4). Do not blow out with an air line, it could be harmful to inhale the dust, but remove with a vacuum cleaner or wipe clean with a damp cloth. Do not use petrol or paraffin, if a solvent is necessary methylated spirit should be used.

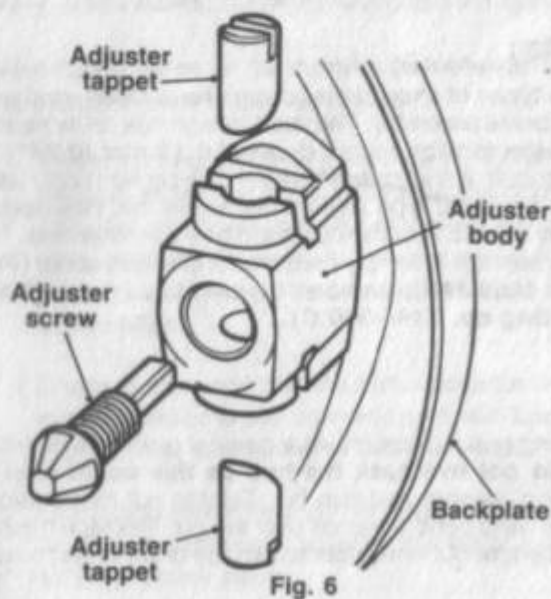
Fig. 6

Unless damaged the adjuster body need not be removed from the backplate. Extract adjuster tappets, unscrew and withdraw adjuster screw. Thoroughly clean the parts, then smear tappets and adjuster screw threads with Lockheed Expander Lubricant. Screw adjuster fully into place to provide minimum adjustment, ensure that the threads of the adjuster stem exposed behind the backplate are well coated with the lubricant. Insert the tappets into adjuster body, the sloping ends coincide with the tapered angle of the adjuster screw. Fig. 6.

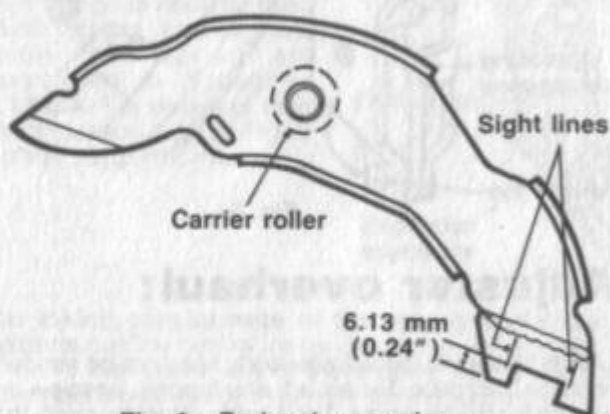
Fig. 8 Brake shoe carrier

Two types of shoe carrier design have been used with this brake assembly. The latest design has an increased adjuster location recess depth of **6.13 mm (0.24")** as illustrated. It is important that the new carrier is only used with the latest type adjuster assembly that has deeper body slots to accommodate the new carrier shape. The new adjuster assembly if required is available under (**Part No. 4158-133**), and can be identified by the (**body casting no. 3144-310 C**).

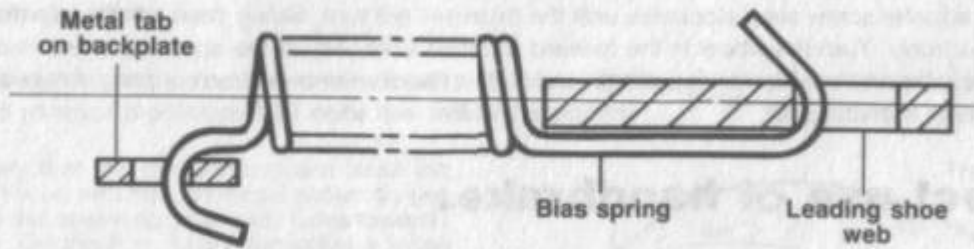
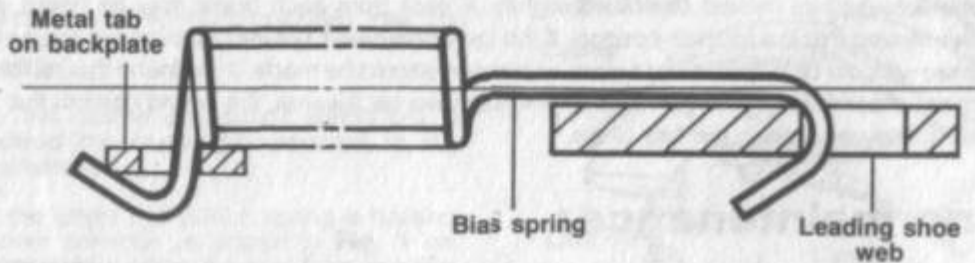
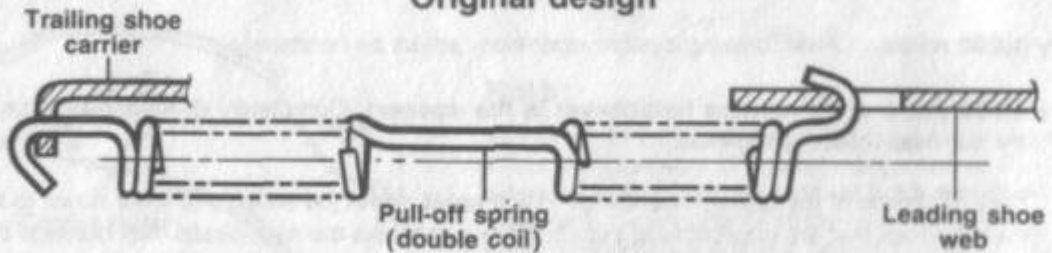
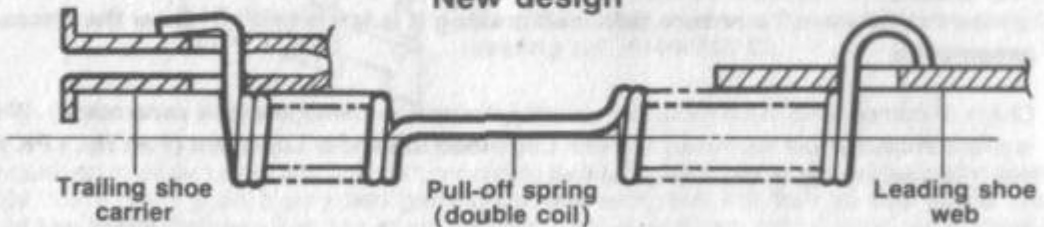
Fig. 9

Location of new design bias spring

Original design

New design

Location of new design pull-off spring

A new design of double coiled pull-off spring and a new design bias spring are incorporated in Spring kit **LK 17056**. For details of their correct location refer to **Fig. 9** on page 12 of this manual.

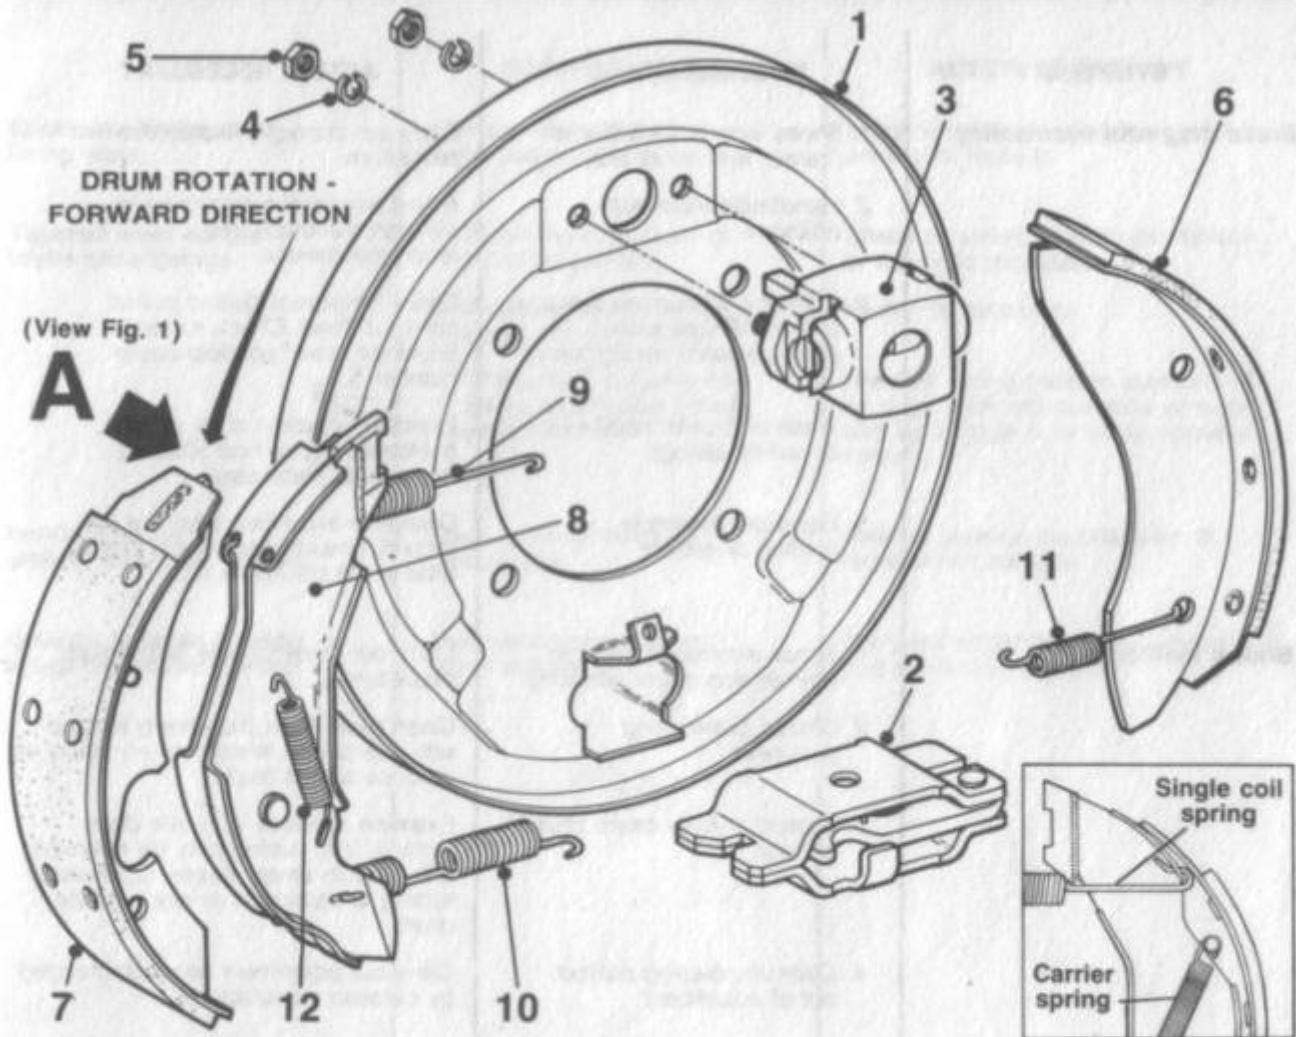
Fig. 1

BRAKE ASSEMBLY COMPLETE

R.H. = LG 15048 L.H. = LG 15049

L.H. BRAKE ASSEMBLY

Description	Kit Part No.	Kit Contents	Description	Kit Part No.	Kit Contents
Backplate	LPP 109	1 Backplate	Spring kit (Axle set)	LK 17056	9 Pull-off spring single coil (2)
Expander assy.	LQ 13605	2 Expander assy.		10 Pull-off spring double coil (Red)	
Brake adjuster	LA 18133	3 Adjuster assy.		10 Pull-off spring double coil (Black)	
		4 Shakeproof washer (2)		11 Bias spring (2)	
		5 Hex nut (2)		12 Carrier spring (4)	
Brake shoes (Axle set)	LS 1258	6 Leading shoe (2)			
Trailing shoe carrier	LPP 110	7 Trailing shoe (2)			
		8 Carrier

4. Check that the single coil pull-off spring is hooked into the carrier correctly as shown in **Fig. 1 on exploded assembly**, which is a view from direction of **arrow 'A'** with the brake shoe assembled to the carrier.
